VESSEL DESCRIPTION: 1989 55' OCEAN "TUFF LIFE II"
HIN: XYU15655L889 / **OFFICIAL #:** 943282

In accordance with the request for a marine survey of the "Tuff Life II", for the purpose of evaluating its present condition and estimating its Fair Market Value and Replacement Cost, I herewith submit my conclusion based on the preceding report. The subject vessel was personally inspected by the undersigned on May 21, 2014.

NAME OF VESSEL:..... **TUFF LIFE II"**
TYPE OF SURVEY:..... **CONDITION AND VALUATION**
PRE/PURCHASE
ESTIMATED MARKET VALUE:..... * **\$ 190,000.00 U.S. DOLLARS**
ESTIMATED REPLACEMENT COST:..... * **\$ 1,200,000.00 U.S. DOLLARS**
MAKE/MODEL OF VESSEL:..... ****55 CONVERTIBLE**
HULL MATERIAL:..... ****GLASS REINFORCED PLASTIC**
HULL TYPE:..... ****MODIFIED VEE**
BUILDER:..... **OCEAN YACHTS**
LENGTH OVERALL (LOA):..... ****55'8"**
BEAM:..... ****16'4"**
DRAFT:..... **** 4'4"**
DISPLACEMENT:..... ****58,000 LBS.**
YEAR BUILT:..... **1989**

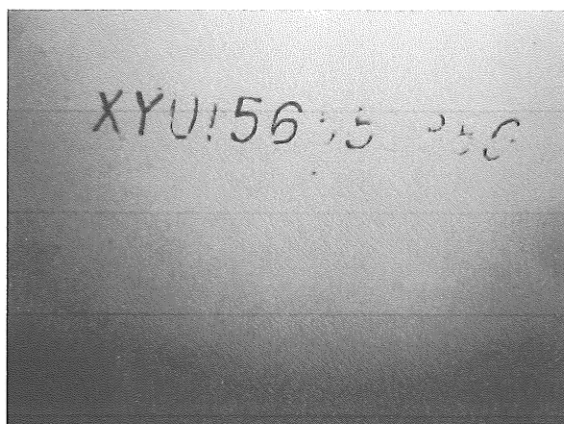
ACTUAL HIN # PHOTOGRAPHED FROM TRANSOM
